This is the possible problem of PS3600 only scanning partial images
Here are some steps to verify and to adjust the Tappet. Tappet = Long thin silver bar that feeds the slides into the scanner.

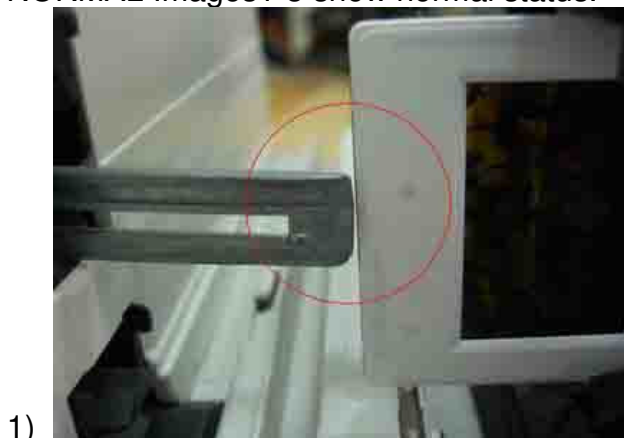
1. NORMAL Images 1-3 shows the device is working normally.
The Tappet touches only the edge of the slide.
2. ABNORMAL Images 4-6 show the device is working improperly.
The Tappet doesn't touch the edge of slide, rather it is pushing it from either side, improperly aligned
So the incorrectly scanned images may appear As shown in frame 13 in Misaligned Image Sample.

NORMAL Images 1-3 show normal status.

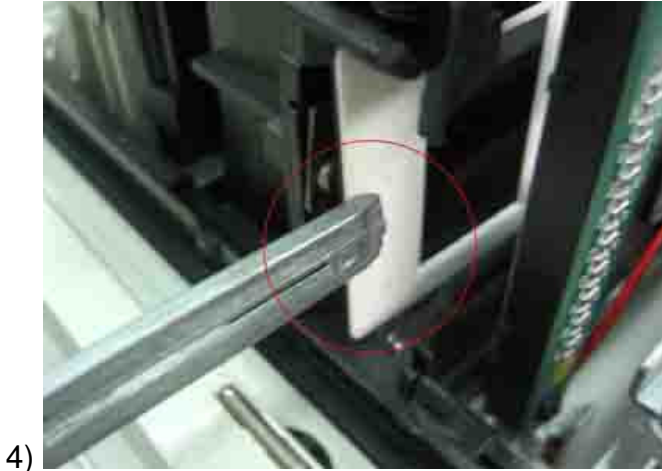
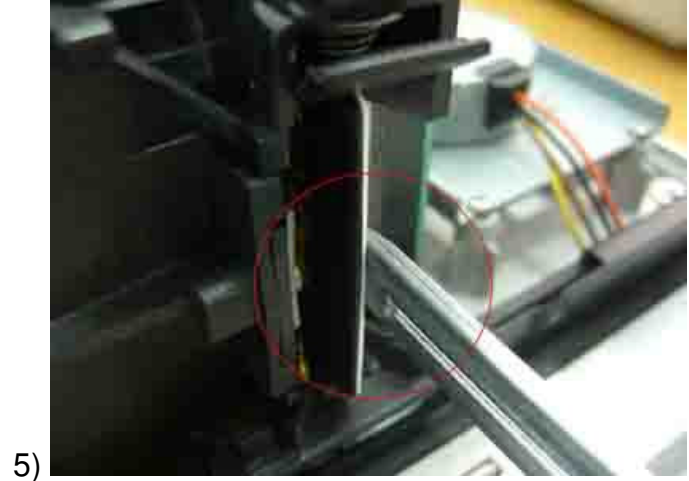
Abnormal 4-6 shows abnormal status.

Step 1. Pull the Tappet in the direction of the arrow as shown in (**Fig. 1**), if the Tappet on your unit is sliding past the slide on the right hand side, if it slides to the left side of the slide then you will need to pull the Tappet in the opposite direction than what is shown in Fig. 1

Step 2. User needs to insert a slide magazine with slides in it, and pull the Tappet in and out to change every slide by a hand.

Step 3. Verify the Tappet is now hitting the center of every slide instead of sliding past it to one side (as shown in ABNORMAL images)
If the problem persists, please try step 1 again.
